Contract #: 04-0120F4Cty: SF/ALA Rte: 80 PM: 13.2/13.9File #: 69.28**WELDING INSPECTION REPORT****Resident Engineer:** Pursell, Gary**Address:** 333 Burma Road**City:** Oakland, CA 94607**Report No:** WIR-020043**Date Inspected:** 06-Apr-2010**Project Name:** SAS Superstructure**OSM Arrival Time:** 645**Prime Contractor:** American Bridge/Fluor Enterprises, a JV**OSM Departure Time:** 1845**Contractor:** Zhenhua Port Machinery Company, Ltd (ZPMC), Changxing Island **Location:** Shanghai, China

WELDING INSPECTION REPORT

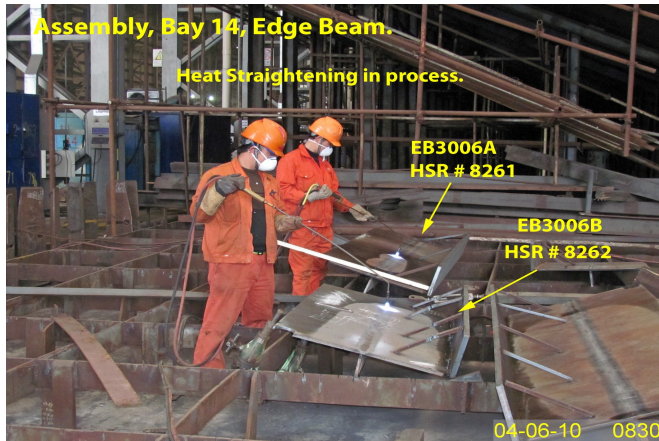
Assembly, Bay 14, Edge Beam.

During Random Visual in process Inspection, this QA inspector observed ZPMC personnel Heat Straightening Edge Beams Identified as EB3006B & EB3006A. ZPMC QC Li Ming Yang showed Heat Straightening Report HSR # 8262 & 8261 respectively. The attached photographs provide additional detail.

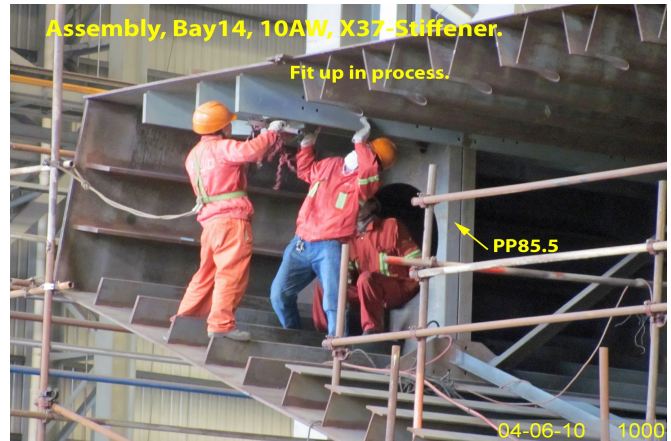
Assembly, Bay 14, 10AW, PP85.5.

During Random Visual in process Inspection, this QA inspector observed fit-up X37-Stiffener at 10AW PP85.5. The attached photographs provide additional detail.
